Manhole Inspection Summary

Manhole # S23MM_025MH

Insp Date: **7/5/07 9:47 AM**

Location Address: **2453 MCCULLOH ST**

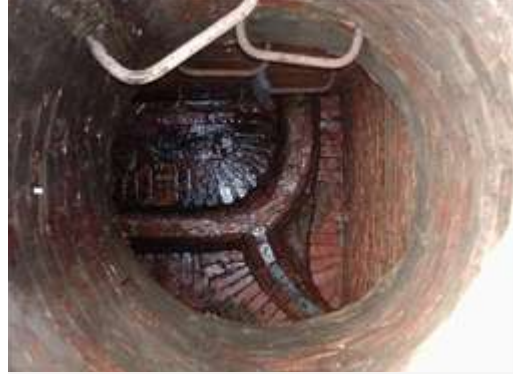
Top View

Corroded steps. Evidence of surcharge - Bench debris.

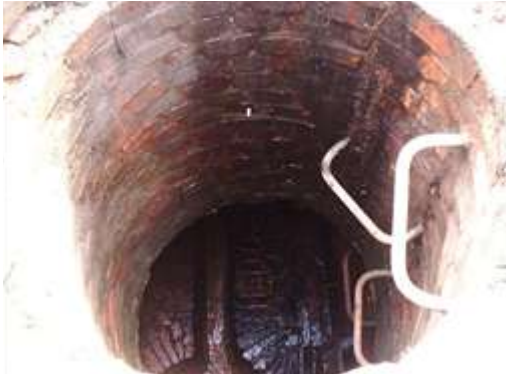
Defect

Frame leaks. Frame offset. Adjustment deterioration and infiltration. Corbel and Barrel infiltration - other side.

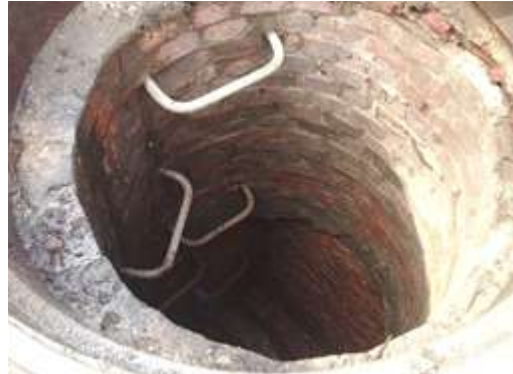
Defect

Frame leaks. Frame offset. Adjustment deterioration and infiltration. Corbel and Barrel infiltration.

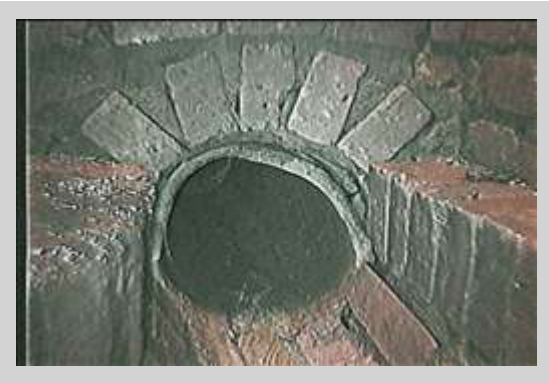
8 in. Circular Gravity Sewer Pipe Out @ 12 O'Clock

Barrel deterioration and infiltration. Channel deterioration.

Infiltration: **Evidence** Pipe Seal Cond: **Cracked**

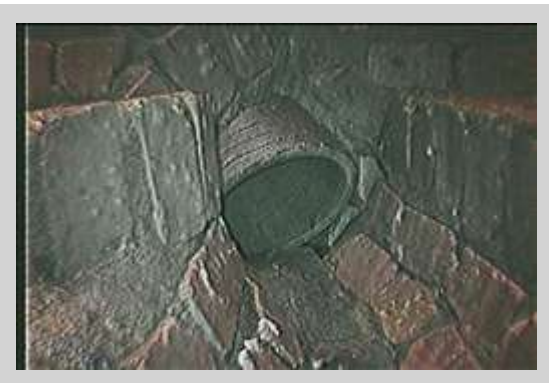
8 in. Circular Gravity Sewer Pipe In @ 5 O'Clock

Barrel deterioration and infiltration. Channel deterioration.

Infiltration: **Evidence** Pipe Seal Cond: **Cracked**
